Continuous Performance Monitoring of Elevators

by Rich Madarasz and Kathy Mutch

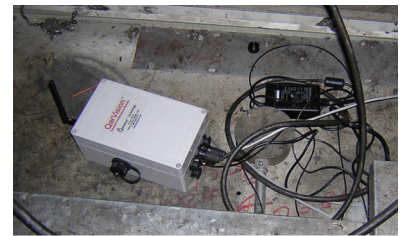
QarVision™ placed on top of elevator car

QarVision has two modules, one to monitor the elevator car, and the other to monitor the machine room equipment. The main module, located on top of the elevator car, measures the acceleration, speed and gate activity. The machine room monitor (MRM) measures motor current, motor temperature, room temperature, hydraulic pressure and relay or magnetic switching. The MRM sends all of its data via Wi-Fi to the main module, which stores the data along with its own. The technician can evaluate the elevator's performance in real time and retrieve stored data wirelessly, using a Wi-Fi-enabled personal data assistant or laptop. The system in the 25-story building also uses a cellular data connection that enables it to be operated remotely from anywhere over the Internet.

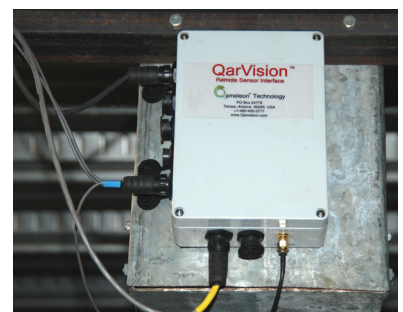
Machine room monitor installed in machine room

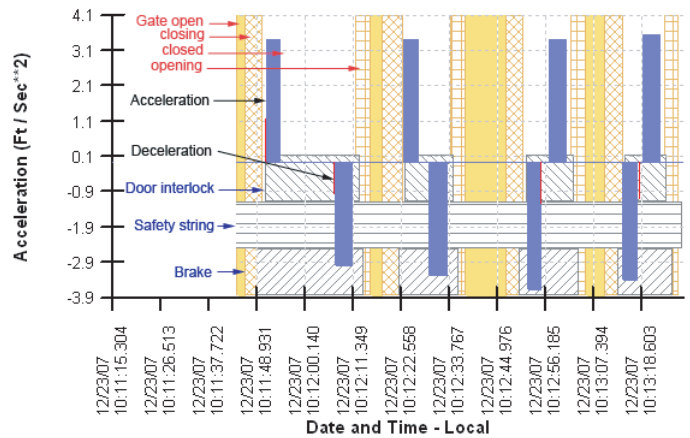
The sensor measurements are recorded for every trip this elevator makes, typically 1,700 trips per day. The retrieved data is analyzed and displayed on a personal computer. The graph in Figure 1 shows a record of some normal trips of the elevator, two trips up and two down. The acceleration and deceleration of the elevator car is shown in a set of blue or red bars. The height of the bar indicates the magnitude of the acceleration, and its width shows the duration. A blue bar is a normal acceleration or deceleration. A red bar is a short acceleration that is out of the ordinary, but not necessarily a problem.

The yellow and white areas behind the acceleration bars show the actions of the gate. They indicate the state of the gate relative to the motion of the car. The width of the hatched areas is the time it takes for the gate to open and close.

The black horizontal bars at the bottom half of the graph show the state of some of the magnetics used in

the elevator. The top bar is the door interlock relay, the middle bar is the safety string and the bottom bar is the brake solenoid. Small magnetic sensors are used to determine the state of the relays and solenoids, without making any electrical connections to the controller.

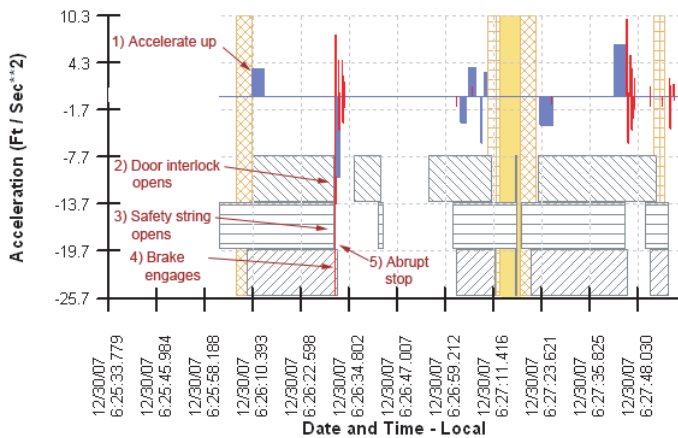
Figure 2

As with most older elevators, intermittent behaviors were occurring, usually when the elevator and building maintenance personnel were not present. One such problem happened early one morning. The graph of this behavior is shown in Figure 2. The elevator started making a normal upward trip at high speed, when suddenly the door interlock relay opened. This, in turn, caused the safety string to open and turn off the elevator. The brake coil then de-energized, causing an abrupt deceleration followed by a bouncing of the car. Then about 20 seconds later, the door interlock closed by itself, resetting the other relays and allowing the car to continue on its trip. The same behavior happened on the next trip. When the recorded data were examined, it showed that this was happening quite often.

Using the data collected by QarVision, the technician quickly found that the problem was caused by an inter-

mittent switch on one of the landing doors. Without the performance data, it was nearly impossible to detect this problem, because it occurred infrequently, and the elevator was either working again or shutdown when the technician arrived. Often when the problem occurred, the elevator restarted on its own, so the passengers did not report the problem.
